THE PECULIARITIES OF HISTORIC SLATE ROOFS

With Examples of Wrongful Condemnations

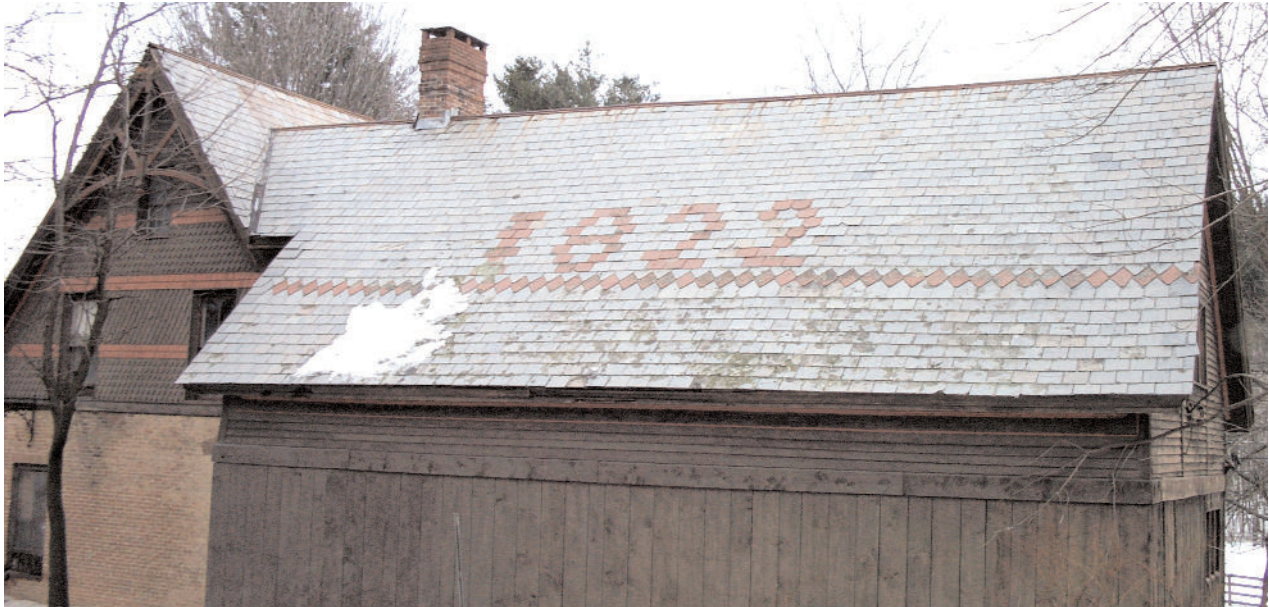
Figure 1: A recent photo of a barn in Vermont testifies to the potential longevity of a standard slate roof.

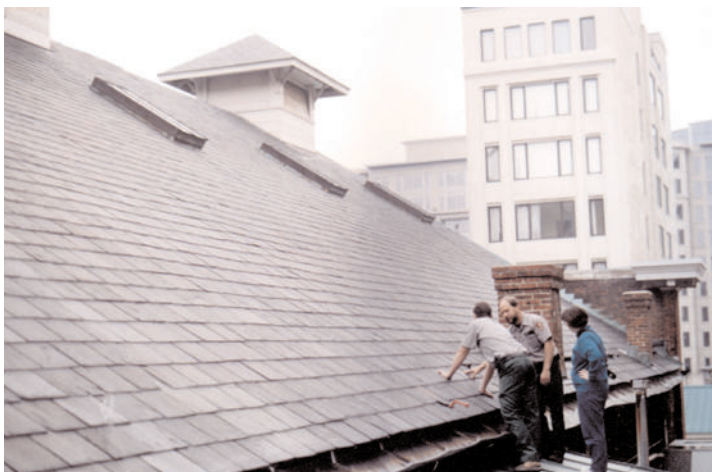
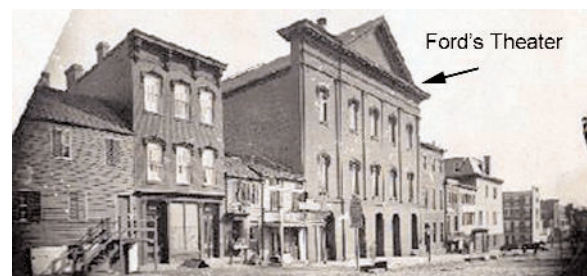
Figure 2: Ford's Theater

If a roof leaks, it must need to be replaced, right? Ford's Theater is the historic site in Washington D.C. where President Lincoln was assassinated in 1865, shortly after the theater opened (Figure 2). In 1998, the slate roof leaked in two places. Standing in the upstairs hallway near a front window, one could see plaster crumbling from the ceiling, indicating a major leak. There was a vantage point outside where one could stand on an adjoining building and get a close-up look at the slate roof on the theater. The slates looked very old; perhaps they were the originals from 1865. Apparently, it was time for a new roof. However, just to play it safe, the author was called in to inspect the roof prior to putting the project up for bid. That was a smart move.

In short, the entire roof and all of the copper flashings had already been replaced and were about 25 years old — quite young for a Buckingham slate roof, which can be expected to last at least 125 years. However, when the original slates were removed, the good ones were saved and recycled back onto one side, coincidentally at the only place where the roof could be easily inspected. It appeared from that vantage point as if the entire roof was still the original slate, but a closer inspection showed that 80% was new slate and only about 20% was original. Furthermore, no current worker at the theater had been there for 25 years and there was no written record of the roof having been replaced, so no one knew that it was already new. The leaks? The front parapet wall copper coping had split at a soldered seam and was channeling water directly into the building down the front wall. The other leak was caused by a defective flashing between the adjoining flat roof and the building wall. The roof itself didn't leak at all. From a slate perspective, it was still a new roof — but almost condemned.

Left photo: This side of the roof looked old because the original 1865 slates were reused here when the roof was replaced around 1975. The right photo shows the front parapet wall. The arrow is pointing to the spot where the copper coping had split — right at the joint — a perfect funnel for rain water.

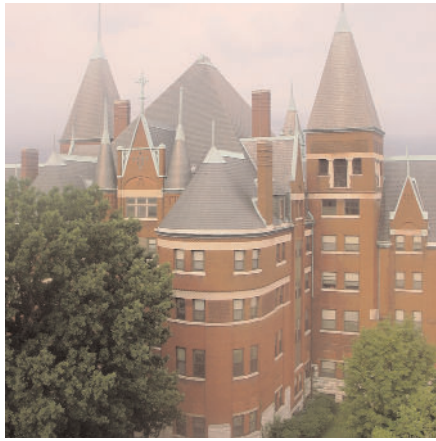
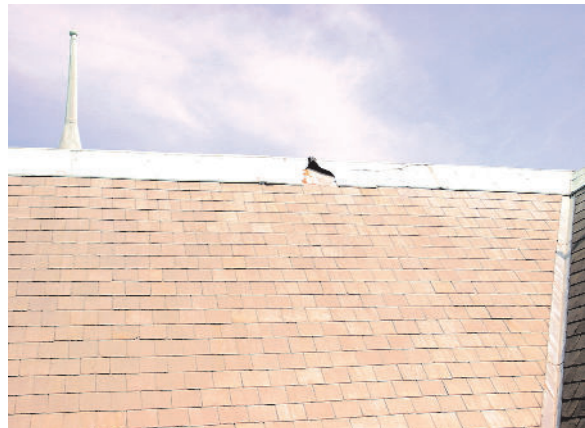
Figure 3: Castle Park

Left photo: This is only the entranceway to the huge building which has large wings emanating in three directions. The slate, at 120 years of age, is in excellent condition. Roofing contractors, however, would love to tear it off. Right photo: The minimal wind damage does not justify replacing the entire roof when the slate is still in good shape. Photos by Joseph Jenkins

The Castle Park building near St. Louis is a huge, sprawling, five-story building with an 850 square slate roof built in 1882 (Figure 3). The roof suffered hail and wind damage in the early 2000s and was subsequently condemned by contractors who offered to replace the roof with asphalt shingles for ten million dollars. The entire roof was original, flashings and all, and some leaking was occurring.

An inspection by the author revealed that the slates were a Buckingham or Peach Bottom variety of exceptional quality. There was essentially no wear visible on the slates after 120 years. The very steep slopes and the semi-dry conditions of the area had helped preserve the copper, most of which was original. The wind and hail damage on the roof was quite limited and all of it was repairable for less than 3% of the replacement cost. The slates themselves could be expected to last another century, although the copper flashings would have to be replaced eventually. The main leak was in a copper valley and was unrelated to the storm damage. Although this beautiful slate could last at least another century, contractors were earnestly attempting to permanently destroy it.

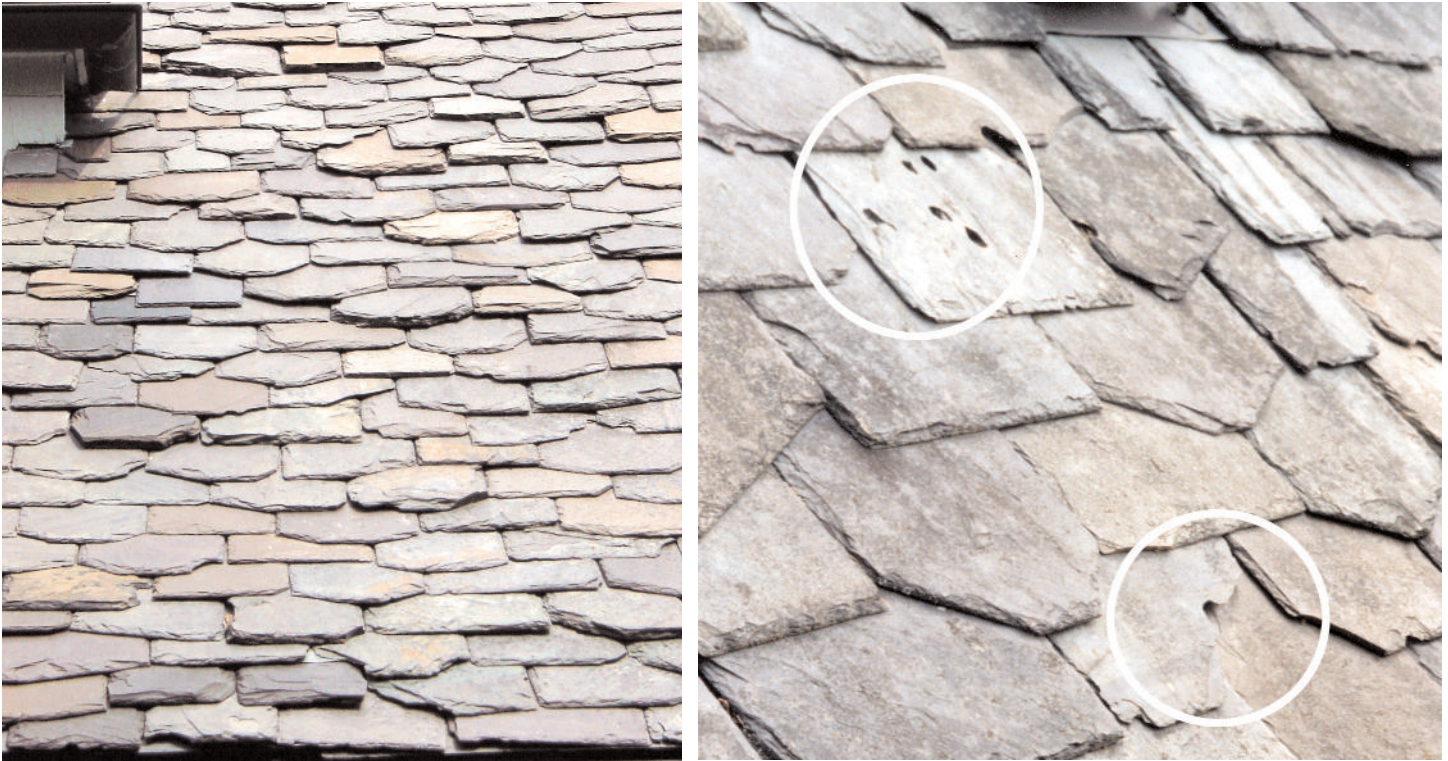
A residence in an upscale Chicago neighborhood suffered hail damage to its unique “battered butt” style 75-year-old slate roof (Figure 4). Three firms looked at the roof and all three condemned it before the owner contacted the author for an impartial inspection. Hail damage to the mixed Vermont and Buckingham slate was certainly evident, but it was limited and all readily repairable by any contractor with a minimum of slate roof restoration experience. The inspection revealed about 150 slates needing to be replaced — a couple days work for experienced professionals.

Figure 4: Chicago area home with beautiful 75 year old “ragged butt” slate roof condemned by three roofing contractors (above left). Hail damage as seen on Chicago area “ragged butt” slate roof (above right) is repairable by simply removing the damaged slates and replacing them. Most of the slates are undamaged. Photos by Joseph Jenkins

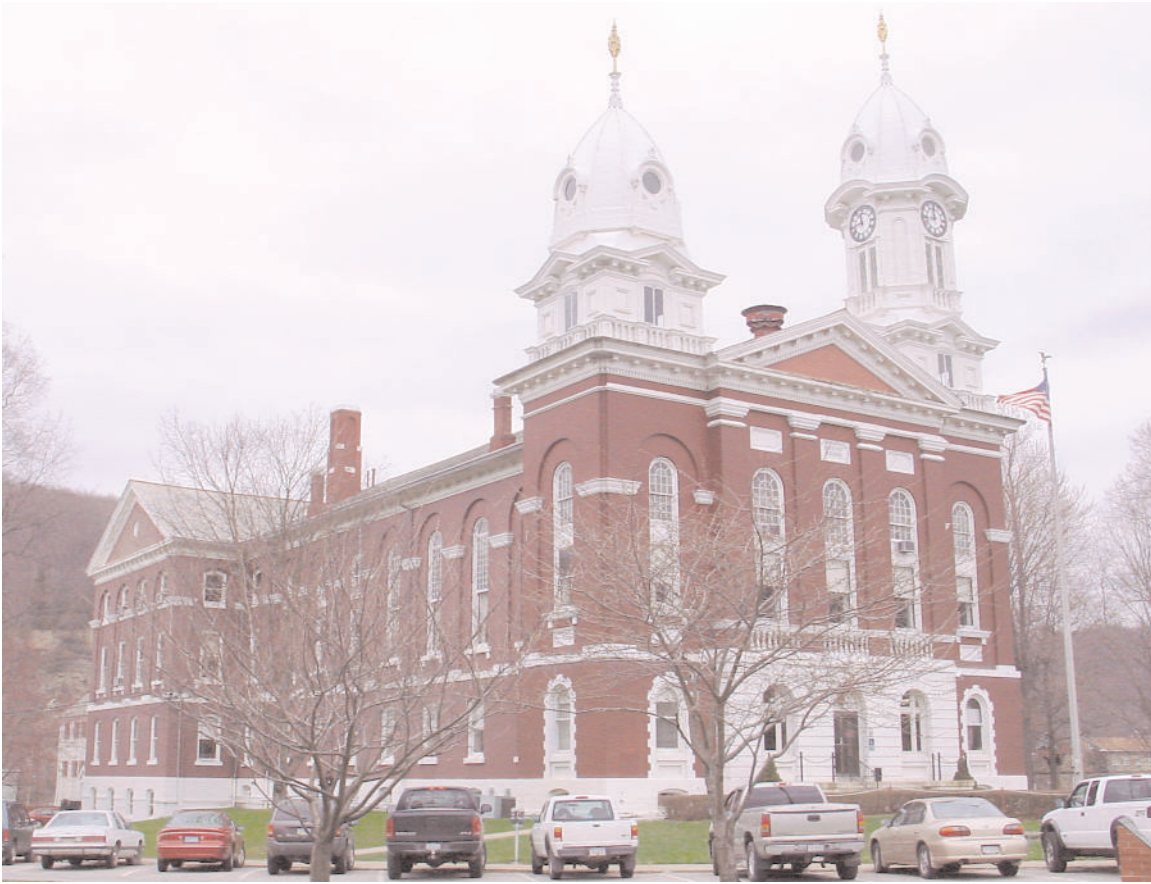
Figure 5: Venango County Courthouse

In 2004, the author was called to consult on the replacement of a Pennsylvania courthouse roof (Figure 5). The 130-square Vermont “sea green” slate roof was approximately 72 years old. A county engineer insisted that the roof was beyond repair and was “absolutely certain” it had to be completely replaced. The author’s

inspection revealed that most of the problems with the roof were related to bad repairs in the past, all reversible. The slate itself was still good and could be expected to last at least another 50 years if not 75 or more. Replacement costs of \$358,451 were reduced to restoration costs of \$35,000, which included replacement of virtually all flashings with stainless steel — a savings to the cash-strapped county of over \$300,000. See photos, next page.

This courthouse roof was unnecessarily condemned and scheduled for replacement. The Vermont “sea green” slate roof is only 72 years old — about halfway through its life. Comprehensive restoration work on this roof will only cost about 10% of the cost for total replacement because the slates and fasteners are still in good condition. Most of the flashings, however, need to be replaced. Photo by Joseph Jenkins

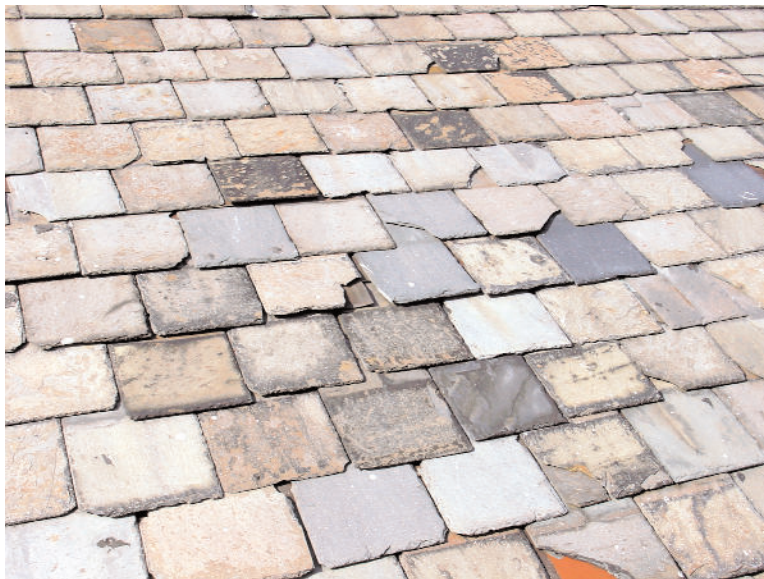
Figure 5A: Most of the problems associated with the courthouse roof were caused by bad repair work over the years, an example of which is shown above. The wrong type and color of slates were used to repair this roof, indicating the repair contractor didn't understand proper restoration techniques. These will all need to be removed and replaced with slates that match the original roof. The author counted approximately 700 slates like this on the courthouse roof. Photo by Joseph Jenkins

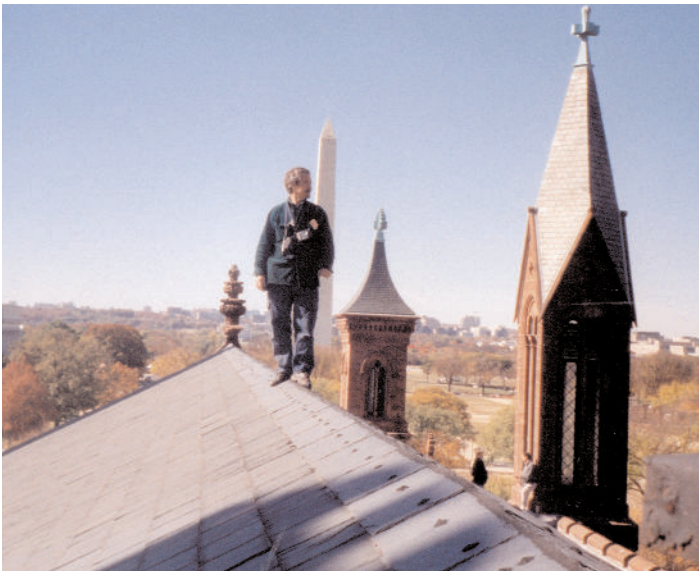
The huge Smithsonian building known as “The Castle” in Washington D.C. has a slate roof measuring several hundred squares in area (Figure 6). In 2000, the roof leaked in several places, generating talk of replacement — a very expensive proposition. An inspection by the author revealed that the roof had recently been replaced — a scenario similar to Ford’s Theater. The slate roof on the Castle was only about 25 years old, having already been replaced with new Buckingham slates (although some of the original slates had been reused). The majority of the flashings had also been replaced with new copper.

Apparently, some of the more important historical buildings in our nation’s capital had been refurbished around the time of the bicentennial in 1976. At about that time, Ford’s Theater got a new roof and so did the Castle. For some unknown reason, however, not all of the Castle’s flashings had been replaced. Four main central valleys and the flashings along two parapet walls had been left as original, and they now leaked. Furthermore, the maintenance crew had the habit of tromping on the slate roof in what appeared to be combat boots, crunching the slates underfoot, breaking them, and adding to the roof problems. The solutions were simple and relatively inexpensive: replace the old flashings with new copper and keep people off the roof who don’t belong there.

Figure 6: The Smithsonian Institution Building known as the Castle had already been replaced with new slate, but some of the original flashings had been left in place, and they leaked. The author is inspecting the roof in the photo above. Photographer unknown.

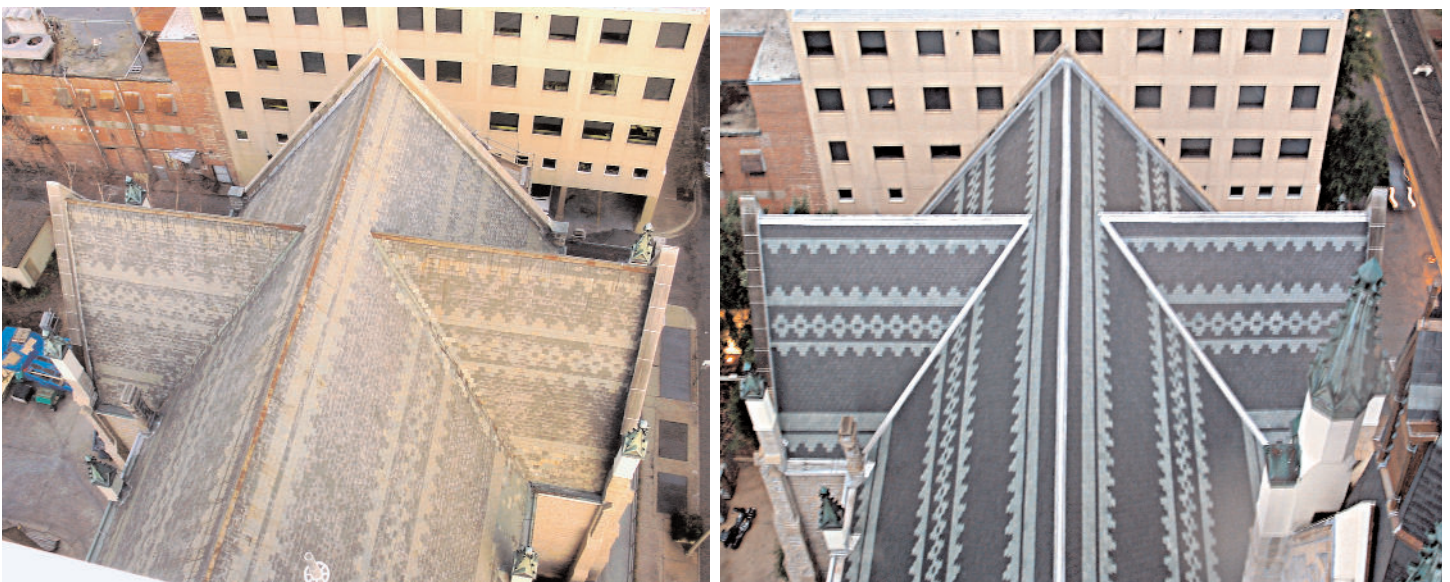
A slate roof will wear out, of course, and at the end of its life, nothing can save it. This was the case with the Cathedral of St. Andrew in Arkansas (Figure 7). The Cathedral roof was made up of Pennsylvania black slates and Vermont unfading green slates mixed in an ornate pattern. At 120 years of age, the PA black slate had simply worn out — become soft, flaky and falling apart, especially on the south exposure and on the main body of the church. The Vermont unfading green slates showed almost no wear at all despite their age of 120 years.

Figure 7: The Cathedral of St. Andrew in Little Rock, Arkansas, had worn out its black Pennsylvania slate after 120 years (above left). The Cathedral's new roof, installed by Midland Engineering in 2003, is likely to last 150 years. Vermont unfading green slate mixed with Welsh black slate and terne-coated stainless steel flashings should out-perform the original roof. Left photo by Joseph Jenkins; right photo by Lyle Bandurski.

The original roof was inspected by the author to determine its condition and to draw up specifications for replacement. The new slate roof was subsequently installed by Midland Engineering of South Bend, Indiana, to match the original roof. This time, however, Vermont unfading green slates were mixed with Welsh black slates from Cwt-y-Bugail. All of the copper flashings were replaced with terne coated stainless steel (some 4-lb. sheet lead was also used). The new slate roof is expected to last at least 150 years.

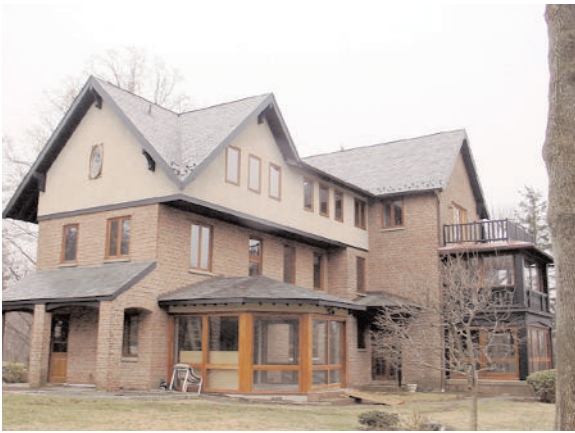
For what it's worth, even newer slate roofs fall prey to unscrupulous roofing contractors. A house just outside New York City had a ten-year-old Vermont mixed slate roof (Figure 8). In the spring of the year the owner found some slates on the ground, along with some snow guards. A local "third generation slate roofing expert" was called to the scene. He promptly condemned the 100 square roof and offered to replace it for \$450,000. The owner then called the author for a second opinion. The author's inspection revealed that the snow guards had let loose due to severe weather that winter combined with an inadequate number of snow guards for the size and slope of the roof. Each snow guard was hooked onto a slating nail causing a slate to be pulled out with

Figure 8: Ten year old slate roof on a private residence condemned by roofing contractors. The nominal snow guard damage, however, was covered by homeowner's insurance — the roof did not need to be replaced at all.

the snow guard. The damages amounted to a maximum of \$10,000 and all of it was covered by homeowner's insurance. Otherwise, the roof was fine. So much for "experts."
